THE IMPACT OF A LIGHTNING STROKE ON A FLAT ROOF WHEN THE BUILDING IS FILLED WITH WATER

Prof.Dr.-Ing. Jan Meppelink

BET Blitzschutz und EMV Technologiezentrum GmbH, Menden, Germany

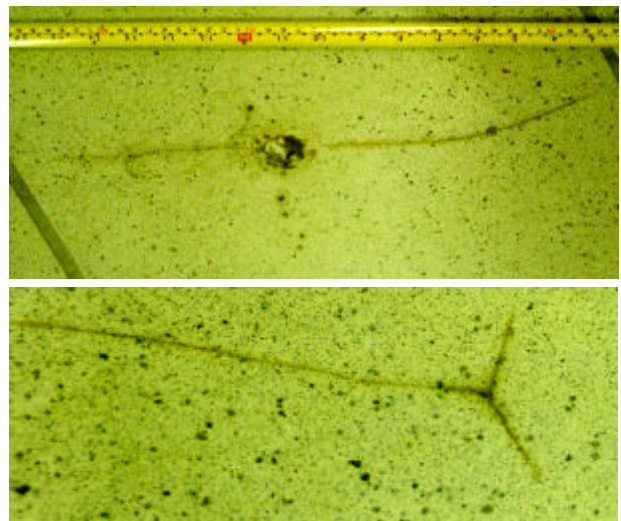
Fig.2: Punctures where parts of the roof are connected to ground in the hall, in the flagstones.

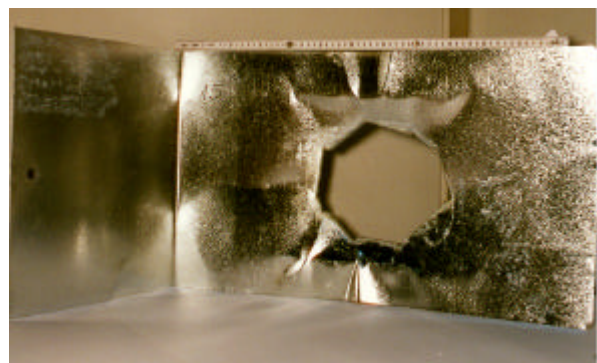
Fig.6 Result of the test with impulse current. Steel Sheet after the discharge. Arc length under water: 1cm; Water level 4 cm. Impulse current: 10/350μs; Peak=54 kA; Charge=10As; Specific Energy=291kJ/m².

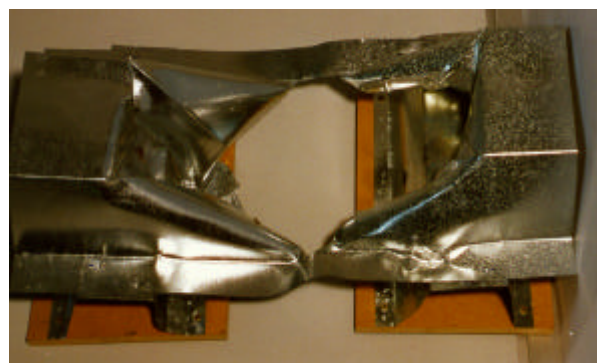
A further experiment was carried out with a trapezoidal sheet steel with the identical dimensions of the destroyed roof. The exploding wire was connected Y-shaped to the steel sheet to two points, each of a length of 12 cm. The result of the experiment with trapezoidal steel sheet is shown in Fig.7.

Fig.7 Trapezoidal steel sheet after the experiment. Arc length under water: 2x12cm. Impulse Current : 10/350μs; Peak= 49,6 kA; Char-

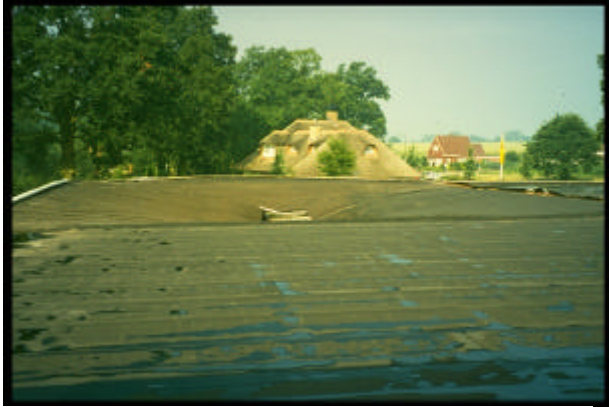
Photo 1 shows the roof of the damaged building (30m x 30m x 3,3m). The roof consists of a sheet construction of trapezoidal sheet steels (Fig. 1). Insulating boards are attached on the trapezoidal sheet steels. Roofing paper covers the hard foam plates. The height of the roof frame is app. 9 cm. Photos 2-4 show the damaged parts of the building. At the time of the event, only one person in the bordering office section of the building was present. According to the

Photo 1
View of the destroyed roof of the building in the Netherlands.

- *Guaranteeing a sufficient water drain to prevent pools of water on a flat roof during a heavy rain fall. However, the danger consists in the malfunction of the rainwater gutters by pollution.*
- *Sufficient slope, so that the water only occurs at the outer zones.*
- *Building a lightning protection system on the flat roof with a collecting electrode and conductors which must be arranged above the maximally possible water level.*

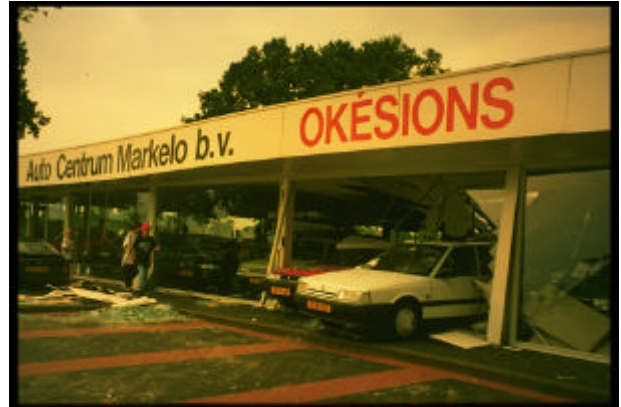
statement of this person, the first flash hit the flat roof. The second flash occurred approximately 3 minutes later and damaged the house telephone. As a result of the first stroke, a strong blast wave shook the whole building. Some cars were moved by the blast wave and ran through the pane of glass. As shown in Fig. 2, there are two punctures, where the parts of the roof touched the ground in the hall, in the flagstones. A coloured crack on both sides which looks like a discharge figure comes from a puncture. Within the radius of some meters, further small spots with similar features have been found. In Photo 2, the hanging down roofing paper can be recognised. The roofing paper was burned according to the statements of the witness on a surface of 3-4 m of diameter and crumbled during touch. A carbonised channel was found at the place of the roof opening through the hard foam plate. The Dutch flash navigation system of the KEMA was used to confirm lightning as a root cause /4/.

It is conceivable that a partial current of the second return stroke or the reported third stroke reached the building in Markelo and that a surface discharge developed itself on the water overcast floor of the building. References on it find themselves in the numerous surface discharge figures on the floor. A tile with discharge figures was opened. No indications of a direct current flow were found included through the soil. Lengths of surface discharges of some meters up to 10 m may be applied here. If the ground is already

Photo 4
Front view of the building. Some cars were moved by the blast wave and ran through the pane of glass

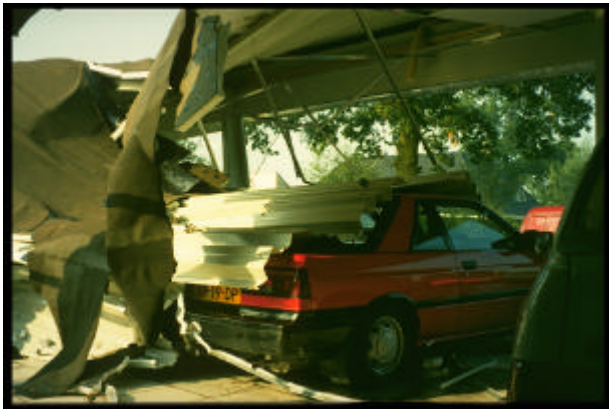
- ◆ The discoloration of the roofing paper indicates a surface discharge at the boundary surface between roofing paper and water.
- ◆ The experiment showed that a conductive

- ◆ Due to a lightning stroke into the water, a surface discharge arises on the boundary surface between roofing paper and water. The conductive channel follows into a bolt through roofing paper. In this case, the energy in the flash channel becomes Electro Hydraulically effective under water. The effective area of the surface discharge under water lies in the range of some meters of diameters according to the information of the witness. The energy in an arc channel in normal air is indicated in literature with 230kWs per meter length. From the fact we can assume a energy dissipation of some 100 to 1000kWs.
- ◆ The lattice structure of metal is cancelled for the duration of shock waves in the ultra short-term field, so that a steel sheet can be formed virtually smoothly.
- ◆ The movement of the cars can not be clarified in the lab for the mentioned reasons.

Photo 2
Detailed view of the roof opening. This is the place where the flash hit the roof.

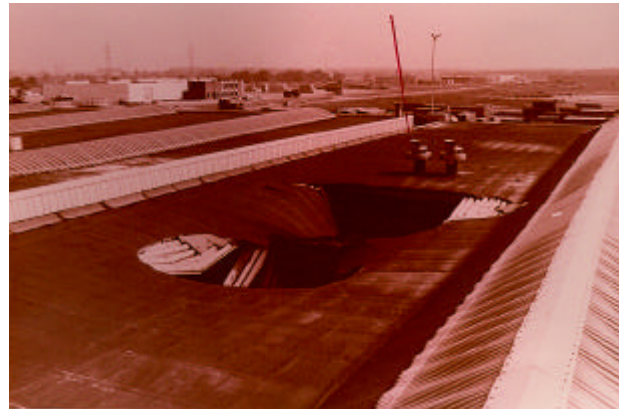
Case 2: Photograph 5. The flat roof of a factory was destroyed in Belgium /2/.

Photo 5
The roof of a Factory in Belgium after a lightning strike. The roof shows two big holes.

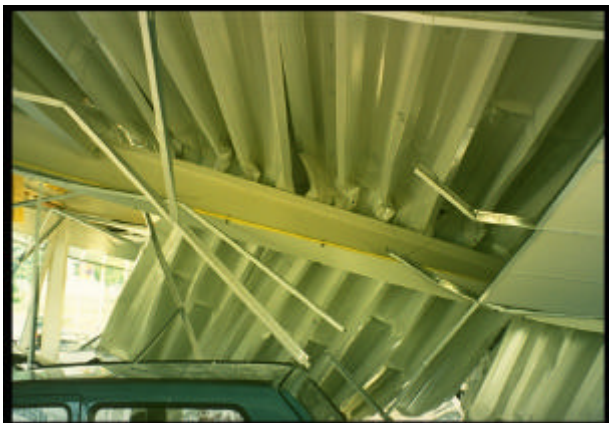
Photo 3
Smashed roof and twisted T-steel girder.

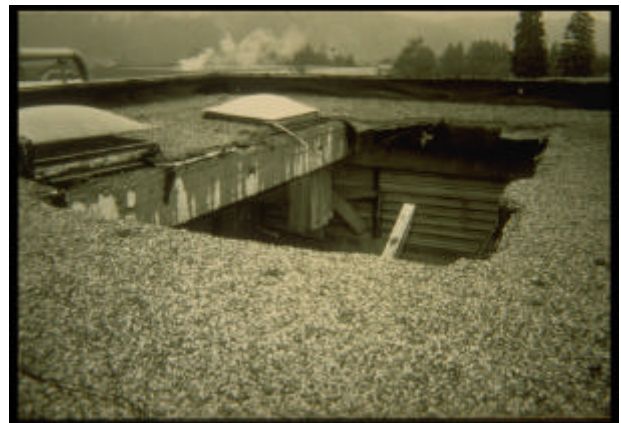
Case 3: Photograph 6. In Austria the roof of a paper factory was destroyed /3/.

Photo 6
The roof of a paper factory in Austria after a lightning strike.
