THE IMPACT OF A LIGHTNING STROKE ON A FLAT ROOF WHEN THE BUILDING IS FILLED WITH WATER

Prof.Dr.-Ing. Jan Meppelink

BET Blitzschutz und EMV Technologiezentrum GmbH, Menden, Germany

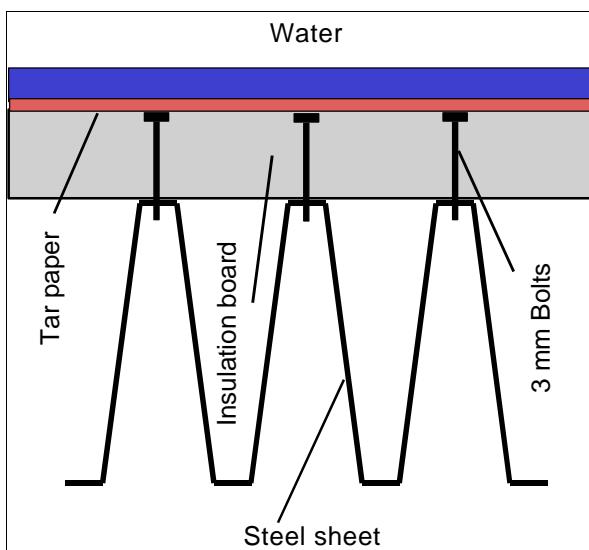
Fig 1: Construction of the roof

Photo 1 shows the roof of the damaged building (30m x 30m x 3,3m). The roof consists of a sheet construction of trapezoidal sheet steels (Fig. 1). Insulating boards are attached on the trapezoidal sheet steels. Roofing paper covers the hard foam plates. The height of the roof frame is app. 9 cm. Photos 2-4 show the damaged parts of the building. At the time of the event, only one person in the bordering office section of the building was present. According to the

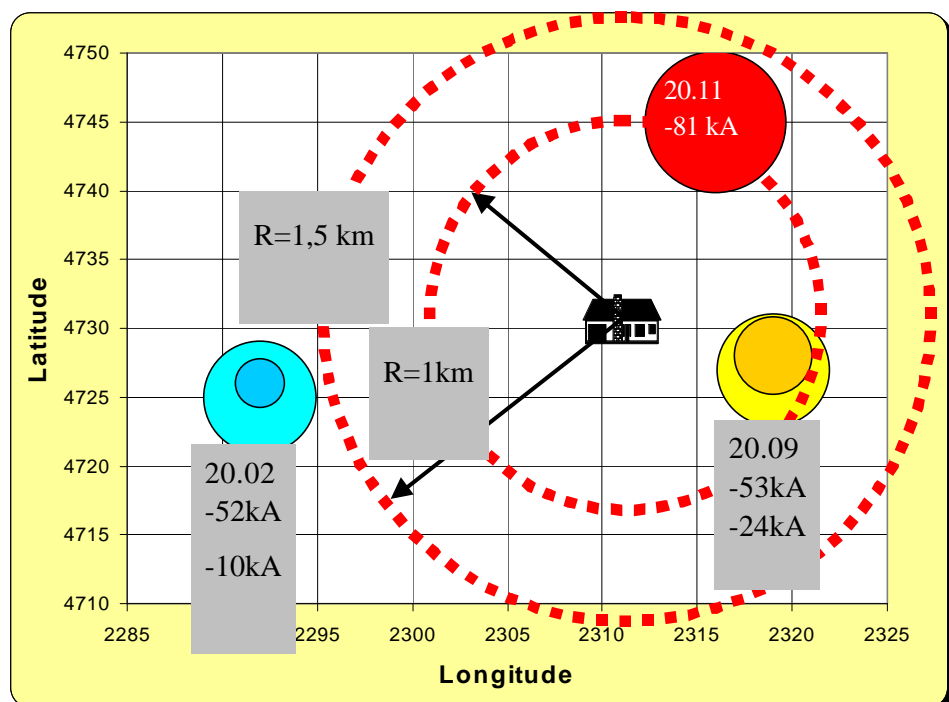
A: 20.02 Distance of approximately 2 km: Consecutive two flashes directly (-52 and -10kA)

B: 20.09 Distance of round 1km: Consecutive two flashes directly (-53 and -24kA)

C: 20.11 Distance of round 1,5 km: A flash (-81kA)
The values B and C are plausible since two flashes were reported at intervals of 3 min. The position of the building in relation to the observed flashes shows Fig. 3. The location area of the system /4/ is also registered there. The observed flashes correspond well within the location boundaries.

Fig.3: The position of the building in relation to the observed flashes. Amersfortse Coordinates, Latitude and Longitude. The diameter of the circles indicates the peak of the registered current. Time and current values are indicated in the diagram.

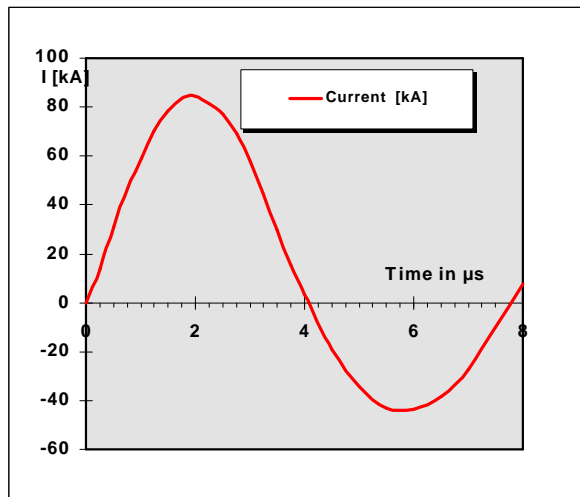
If an electrical discharge takes place below a water surface, a blast wave is formed by the expansion of the arc channel. This mechanism is known /7/, /8/ as the Electro Hydraulic Effect. A blast wave propagates with supersonic speed concentrically to the discharge channel. Fig. 4 shows an analysis of the physical courses of events of a run-off water spark after calculations from Martin/ 9/. Fig.4a shows the injected impulse current. Fig.2b shows the charge injected into the arc channel versus time. The channel diameter of the arc is enlarged within some micro seconds from zero to some mm. As a result, a shock wave is generated. The pressure distribution at the surface of the arc versus time is represented in Fig. 1c. The generated pressure at the boundary of the arc decreases from a value of 35000 atm to 3500 atm within a few micro seconds. This Effect is reverse proportional to the rise time of the current. The velocity decreases to a value of app 100 m/s.

Fig. 4 a The shape of the injected current.

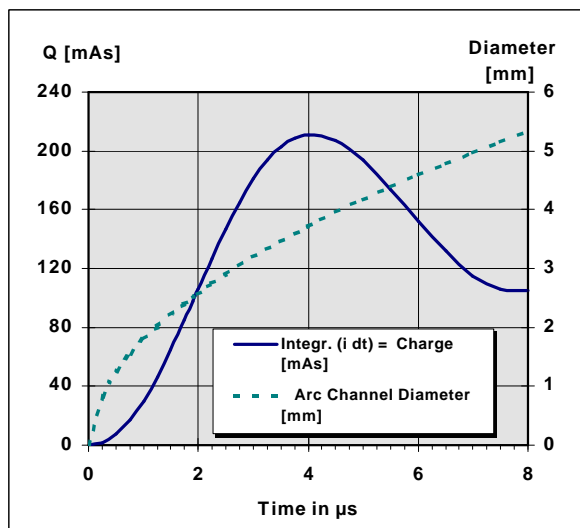
Fig. 4b The Charge and the arc channel diameter versus time.

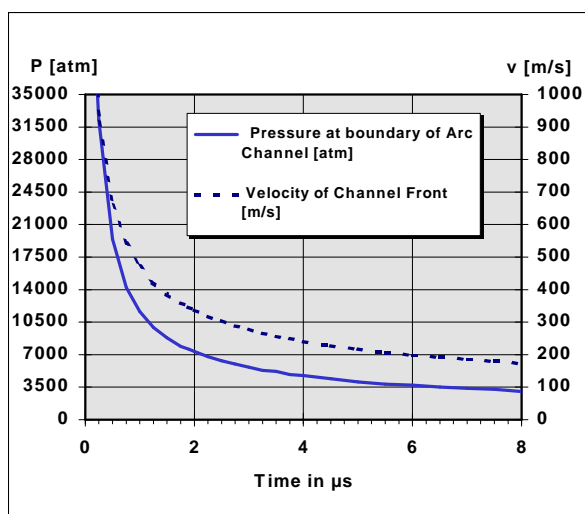
Fig. 4c:
The pressure at the boundary between arc and water as well as the velocity of the propagating front wave versus time.

Fig. 4: Results of calculations of the effect of a current flow through water under impulse conditions according to Martin,E.A.: The underwater spark, an example of gaseous conduction at about 10000 atmospheres. Dissertation University of Michigan

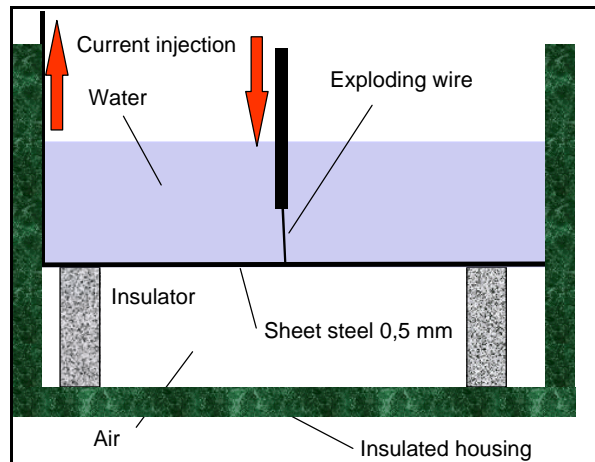
The hypothesis described in the former chapter is based on an Electro Hydraulic Effect caused by a flash channel below the water surface. Therefore it must be proven that the shock wave created in this case was capable to damage a roof. For the experiments, the model of the roof represented in Fig.5 was constructed and loaded with a discharge. An exploding wire with a length of 1 cm was employed to simulate the spark channel of the return stroke. A current impulse 10/350 μ s was then injected into this wire. Without water, however also with exploding wire, a focal spot is only left during a discharge injection on sheet steel where little metal only evaporates. However, the experimental result varies clearly with a water filling: The effect of this discharge on the metal plate is represented in Fig.6. The sheet steel shows an aperture from approx. 350 cm². Therefore, this mechanism, known as the Electro Hydraulic Effect, can be applied to the damage case in question. In this case and the further carried out experiments, the energy input was between 5 and 10kWs.

Fig.5 Model used in laboratory experiments to investigate the effect of an under water spark to a sheet steel.
